**Flood Control Project Maintenance
Levee Inspections**

Fall 2018 Levee Maintenance Deficiency Summary Report

San Joaquin River Basin

**Flood Control Project Maintenance
Levee Inspections****LMA District Cover Sheet****Fall 2018 Levee Inspection Results****Reclamation District No. 0404 Boggs**

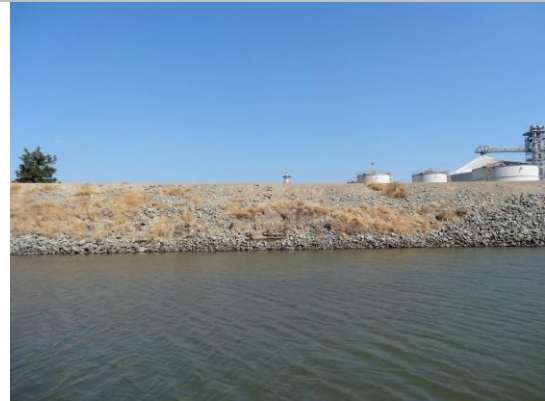
Front view of the erosion.

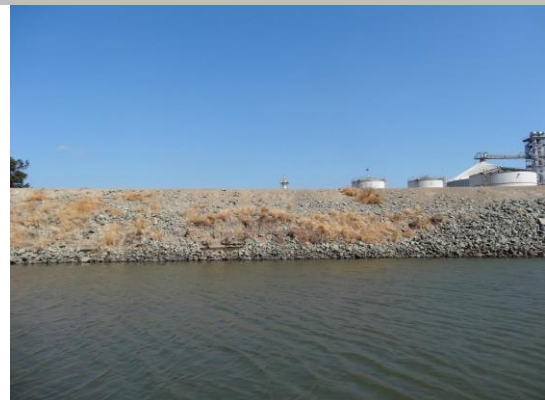
Front of the erosion.

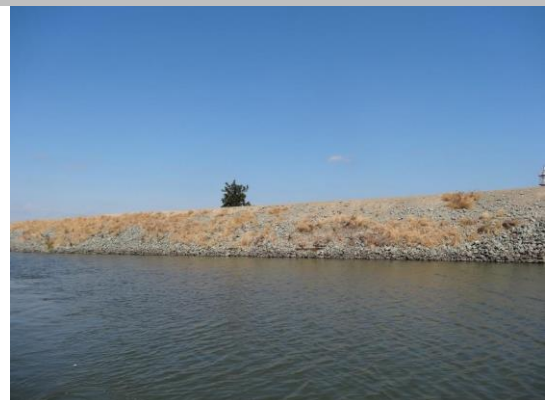
Looking downstream at the erosion site.

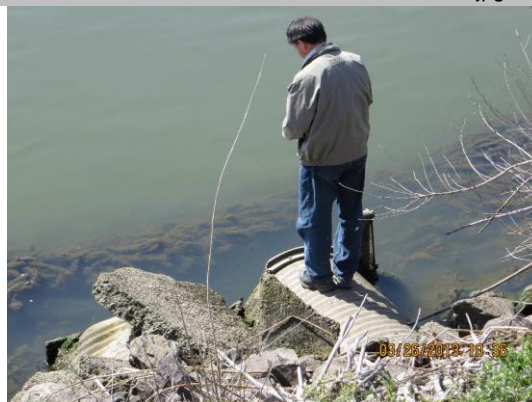
Photo 2 of 3 : UCIP_FA_2018_53346_20081.jpg

WS- left CM pipe with missing flap gate

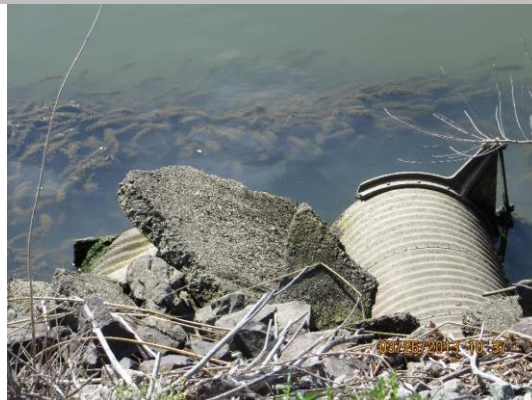
Photo 3 of 3 : UCIP_FA_2018_53346_20080.jpg

WS- closer look at left CM pipe with missing flap gate

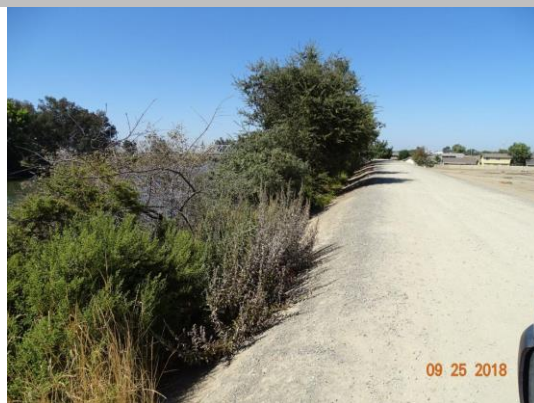
Photo 1 of 2 : FA_2018_RD0404_305_23_20180927_00058.jpg

LM Start	0.60	Rating **	A/W	Issue No.	23		
LM End	0.65	Issue Type +	Ob	Location *	LS		
Category	Earthen Levee			GPS Latitude/Longitude			
				Start		End	
Item	Vegetation				°		°
					°		°
DWR ID	DWR_RD0404_01_f_2018_23						
Comment Code							
V8 : Environmental Requirements.							
Inspector Comment							
Site is not being maintained and is overgrown.

Looking northwest at overgrown site on waterward slope. (Fall 2018)

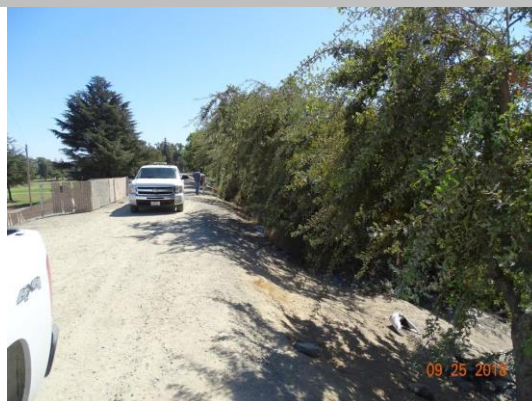
Photo 2 of 2 : FA_2018_RD0404_305_23_20180927_00059.jpg

Looking southwest at overgrown site on waterward slope. (Fall 2018)

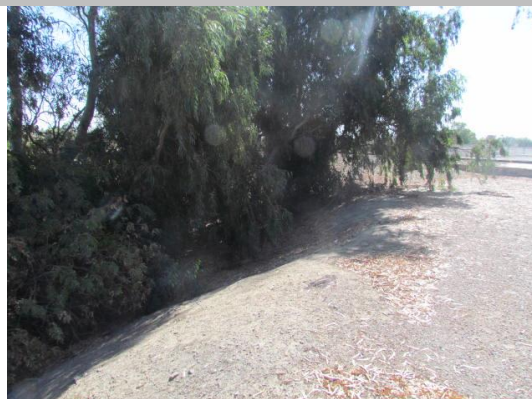
Photo 1 of 1 : FA_2018_RD0404_305_8_20180906_00004.jpg

LM Start	0.78	Rating **	M	Issue No.	8							
LM End	0.78	Issue Type +	Ma	Location *	LS							
Category	Earthen Levee		GPS Latitude/Longitude									
			Start	End								
Item	Trim / Thin Trees		37.937395°	37.937395°								
			-121.333883°	-121.333883°								
DWR ID	DWR_RD0404_01_s_2013_8											
Comment Code												
T1 : Trim trees to at least five feet above ground level.												
Inspector Comment												
Trees are blocking view of the slope.

Looking southeast at dense trees on landward slope and toe.

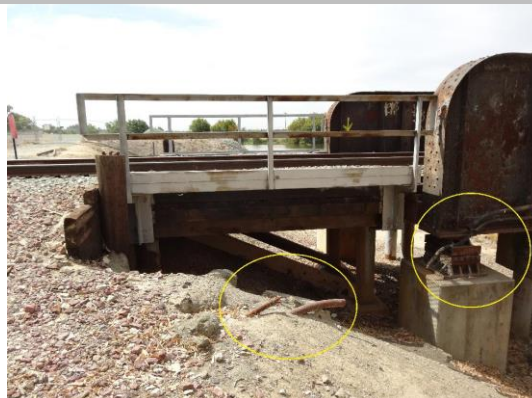
Photo 1 of 3 : UCIP_FA_2018_46810_74753.jpg

LM Start	0.79	Rating **	M	Issue No.	108	
LM End	0.79	Issue Type +	En	Location *		
Category	Supplemental			GPS Latitude/Longitude		
				Start	End	
Item	DWR UCIP Field Study			37.937212°	37.937212°	
				-121.333762°	-121.333762°	
DWR ID	17946					
Comment Code						
Inspector Comment						
FS_ID:46810						
DS_ID:17946						
EP_NO: N/A						
Repair Type: Non-Urgent						
Crossing Status: Found						
UCIP Comments: Appears abandoned; if so should be done so properly.						
FIELD_STRUCT_DESC: Telephone conduit of an unknown size or material through both levees and under the San Joaquin River, at an unknown depth. This buried telephone cable is no longer operational.						
[Additional Reference(s): DWR Levee Log, 2006].						
FS Date: 8/4/2015

WS view looking south: conduits penetrating levee slope now disconnected with those attached to bridge

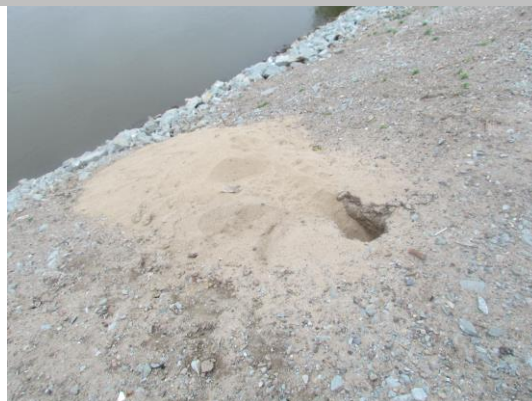
Photo 2 of 2 : FA_2018_RD0404_305_42_20180906_00017.jpg

LM Start	0.98	Rating **	U	Issue No.	42 (cont)
LM End	0.98	Issue Type +	Ma	Location *	WS

Looking northwest at large animal hole (den) on waterward shoulder.

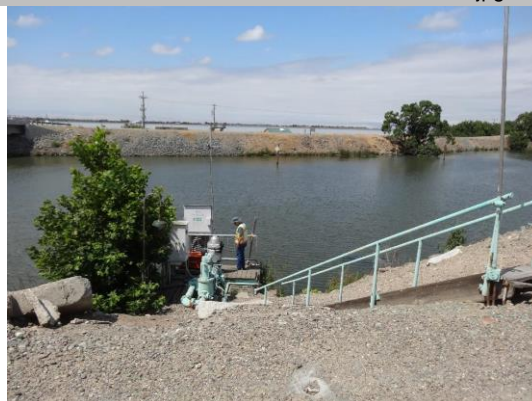
Photo 2 of 3 : UCIP_FA_2018_46801_74747.jpg

Comment Code					
Inspector Comment					
FS_ID:46801 DS_ID:25128 EP_NO: 1164 Repair Type: Non-Urgent Crossing Status: Indicator Found UCIP Comments: Conversation with WWTP engineer Ali Gharegozloo suggested this pipe has been welded shut. If so, mode of abandonment needs verification. FIELD_STRUCT_DESC: 60-inch lock joint reinforced concrete sewage effluent pipe under the levee, 27 feet below the crown. Reinforced concrete apron and cutoff walls. Steel sheet piling apron installed with the pipe on the waterside (WS) slope. Headwall, stairs, and pump with shutoff valve visible on the WS slope. Apparent shutoff valves 30 feet off the landside (LS) toe in alignment with the pipe. (Plans for the construction of a 60-inch lock joint reinforced concrete sewage effluent pipe under the easterly levee of the San Joaquin River authorized under Permit No. 1164, 1947 - City of Stockton). FS Date: 7/9/2015

WS view: pump with shutoff valves, headwall, stairs visible. Concrete debris along WS slope.

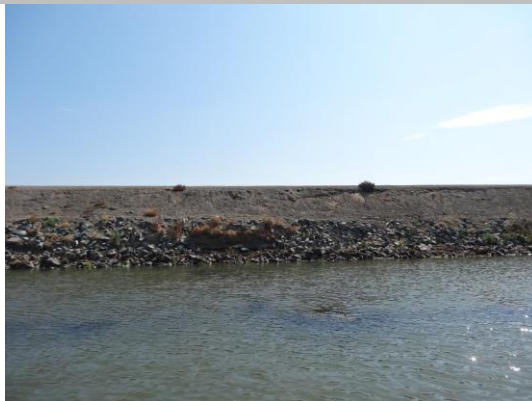
Photo 2 of 2 : FA_2018_RD0404_305_11_20180906_00006.jpg

Close view of the erosion. Note the protection on the lower levee slope.

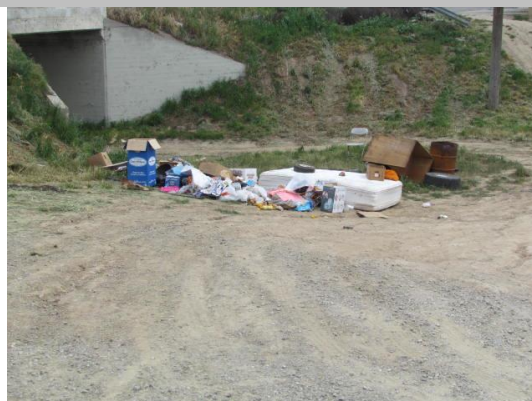
Photo 1 of 1 : FA_2018_RD0404_305_36_20180906_00015.jpg

Looking east at garbage on landward slope and toe.

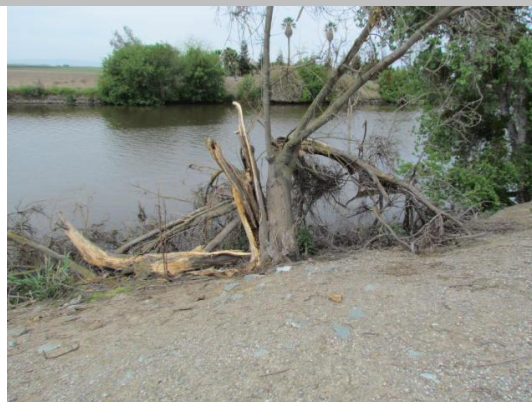
Photo 1 of 1 : FA_2018_RD0404_305_33_20180906_00014.jpg

Looking west at dead tree on waterward slope.

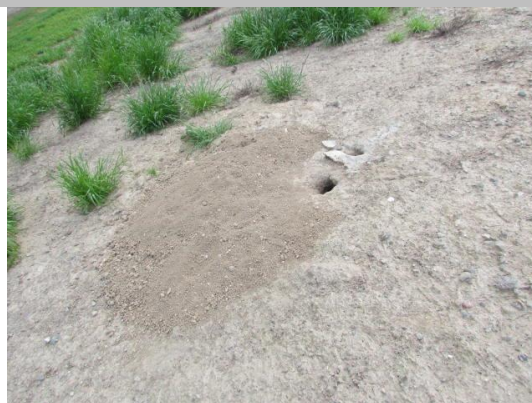
Photo 1 of 2 : FA_2018_RD0404_306_21_20180906_00009.jpg

Looking northeast at large rodent hole on landward slope.

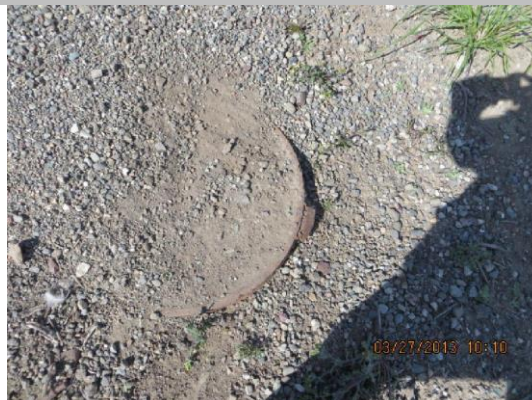
Photo 2 of 3 : UCIP_FA_2018_10908_18181.jpg

WS- damaged, obstructed and buried siphon breaker

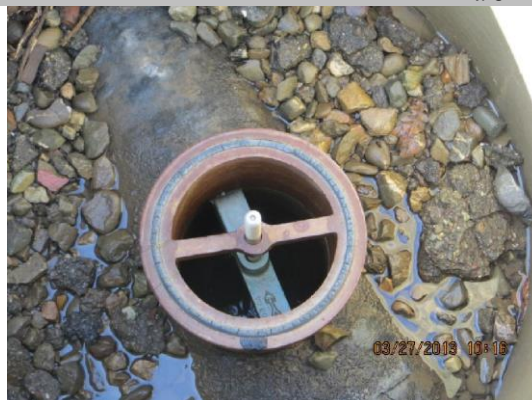
Photo 1 of 3 : UCIP_FA_2018_10945_18248.jpg

WS- siphon breaker without cap in concrete riser
